Figure 7-18 Hole Pattern Identified as Datum Feature

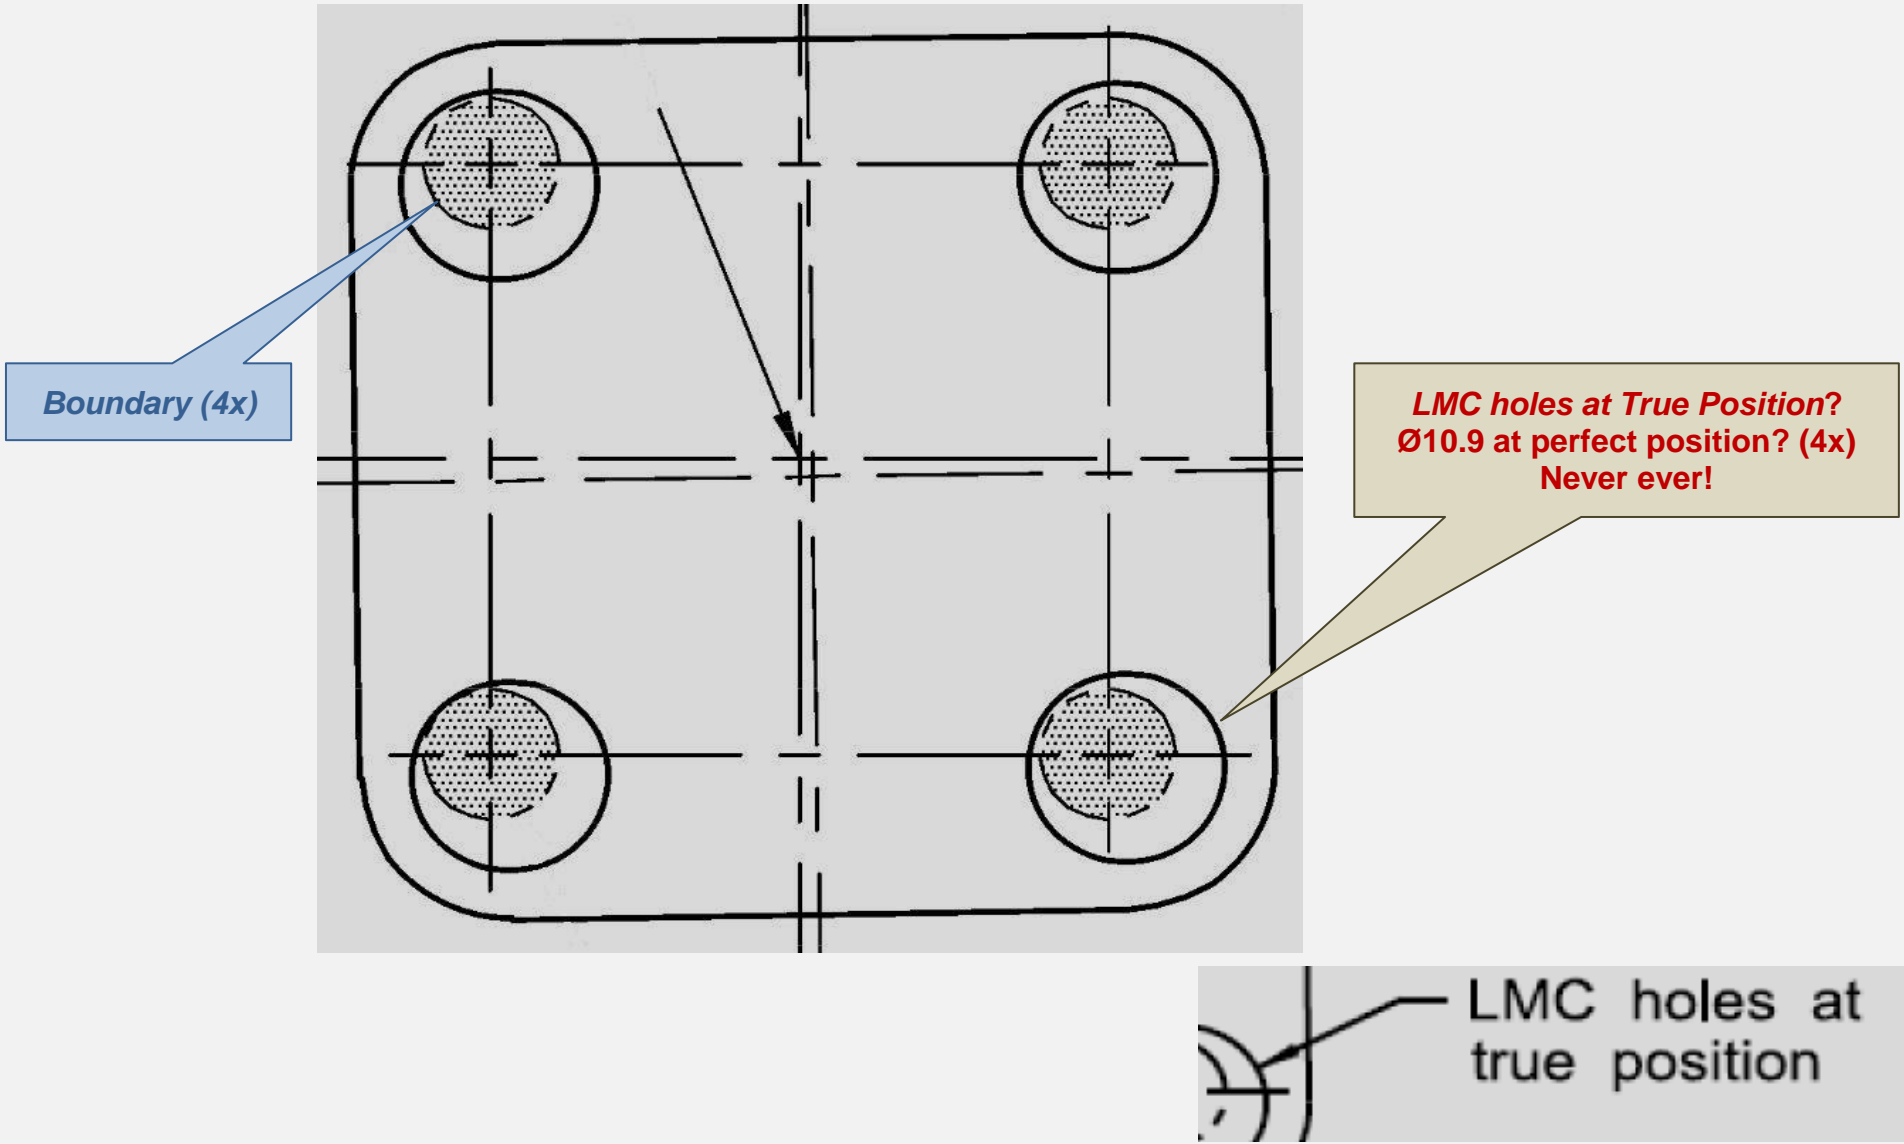
Boundary (4x)

LMC holes at True Position?  
Ø10.9 at perfect position? (4x)  
Never ever!

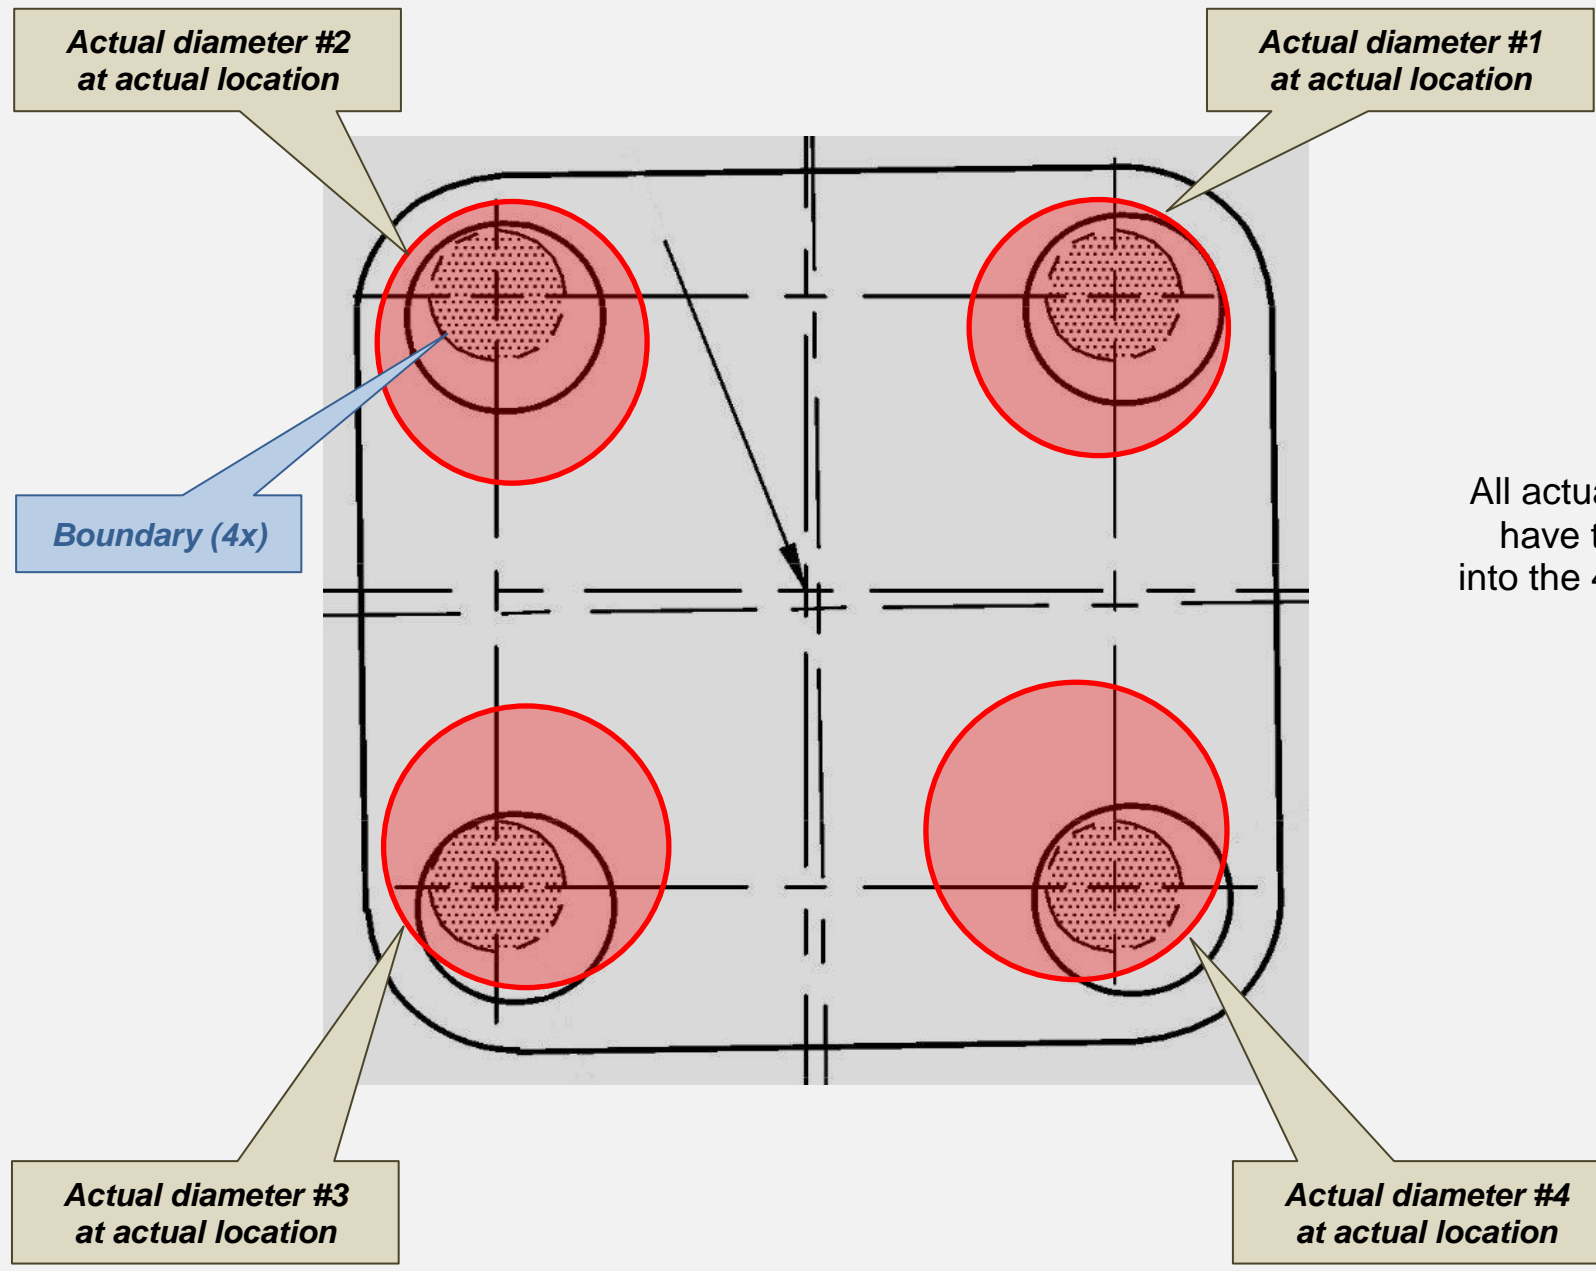
LMC holes at true position
